# Surgical Repair of a Rostral Maxillary Beak Fracture Using an Improvised Metal Implant Scaffolding and Dental Acrylic Prosthesis in a Pet Double Yellow-Headed Amazon Parrot (*Amazona ochrocephala oratrix*)

## ABSTRACT

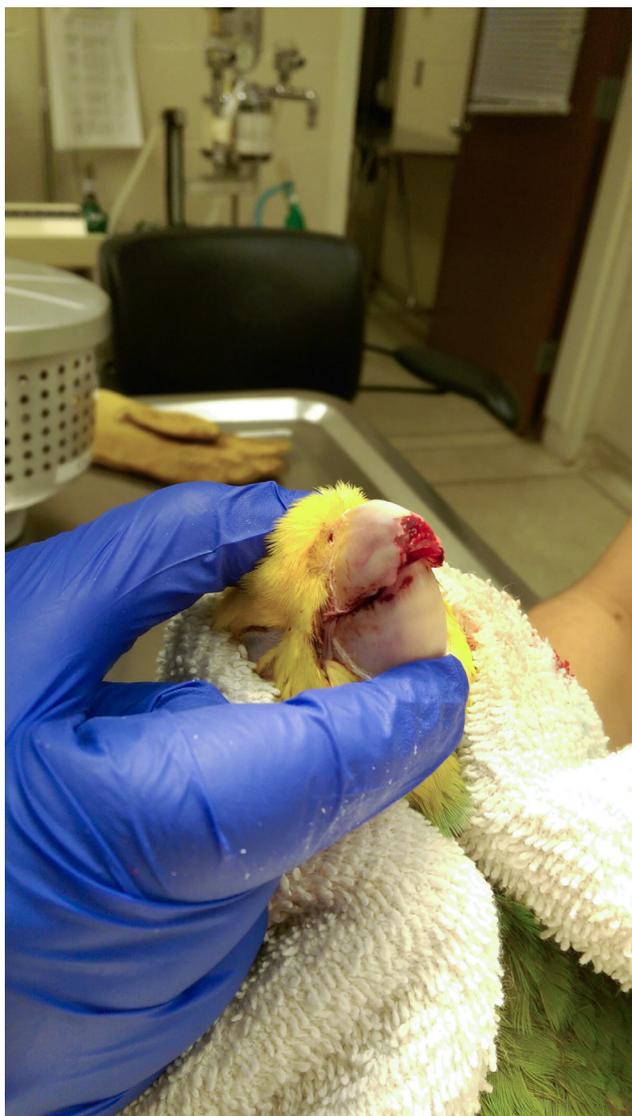
**Figure 1:** Open complete fracture to the rostrum maxillaris in a 23 year-old intact male double-yellow headed Amazon parrot. The fracture was caused by a fall from five feet in height at home. This resulted in exposure of the underlying bone and vascular supply.

A 23-year-old 470-g (1.036-lb) intact male pet double yellow-headed Amazon parrot (*Amazona ochrocephala oratrix*) was evaluated due to a fractured maxillary beak acquired from a fall from a height of five feet. On physical examination, the bird was quiet, alert, and responsive with normal respiratory effort. Closer beak examination revealed an open complete fracture to the rostrum maxillaris with irregular edges, exposing the underlying bone and blood supply (Figure 1). The rostral third of the maxilla was absent and the fracture site was bleeding slightly due to the initial injury. The rest of the physical examination was unremarkable.

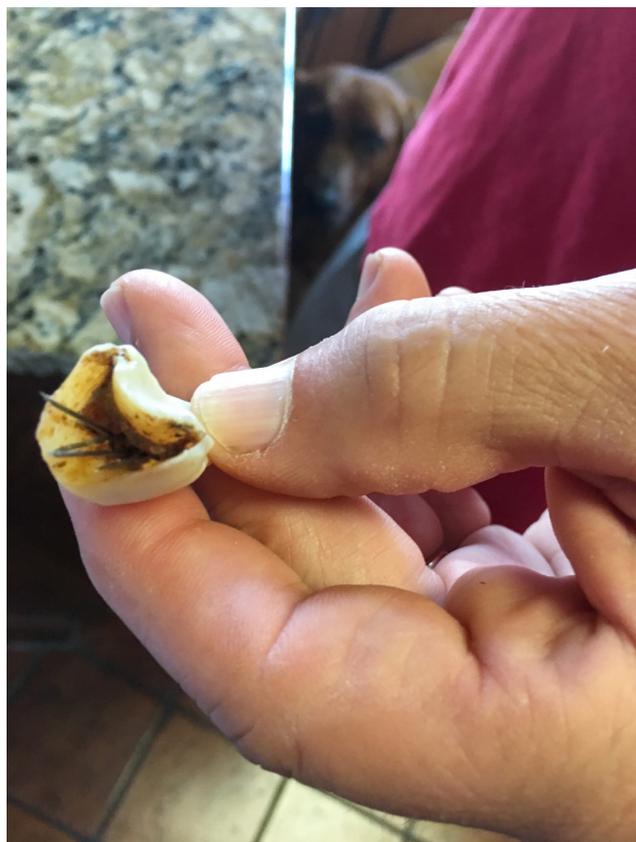
**Figure 2:** Prosthetic created for the bird from Figure 1 to repair the fracture. Five 23-gauge, 1.5in hypodermic needles were placed in the cortex and the cancellous bone of the maxilla. Four needles were placed bilaterally, with two on each side, and one dorsally to create a supportive framework.

The patient was placed in sternal recumbency, and the fracture site was aseptically prepared with a chlorhexidine (2%) solution. Five 23-gauge, 1.5 inch hypodermic needles (23-gauge, 1-1.5 inch hypodermic needle Exelint International Co., Redondo Beach, CA, USA) were inserted between the cortex and the cancellous bone of the maxilla. Two needles were placed along the lateral margin, with the distal ends angled towards one another, on each side. One needle was placed dorsally. This created a pyramidal scaffolding to provide prosthesis stability (Figure 2). The free ends of each needle protruded approximately 3 cm from the rostral tip of the exposed bone and were secured together using a single 28-gauge wire loop (28-gauge stainless steel wire, Integra Miltex, York, PA, USA). A layer of dental acrylic (Protemp Plus, 3M ESPE Dental Products, Saint Paul, MN, USA) was placed over the scaffolding to provide additional stability. Once the first layer hardened, a pilot hole was created through the rostral lateral aspects of the rhinotheca using a 23-gauge needle. A 28-gauge wire was passed through the hole and secured as a free loop, providing bilateral anchoring and stabilization for a second layer of the dental acrylic that was placed around the entire rostral aspect of the maxilla, creating a prosthesis. Dental radiography was performed to confirm correct implant placement (Figure

The prosthesis utilized for the parrot of the present report was able to overcome this challenge through its unique scaffolding framework. The framework consisted of hypodermic needles placed in a pyramidal shape and multiple layers of dental acrylic. This might have distributed the forces evenly throughout the prosthesis and increased its stability, thus allowing it to sustain stronger compression forces at the fracture site compared to an acrylic cap alone (4). The strength of this design prolonged the use of the prosthesis and decreased the need for repeated repairs or adjustments.

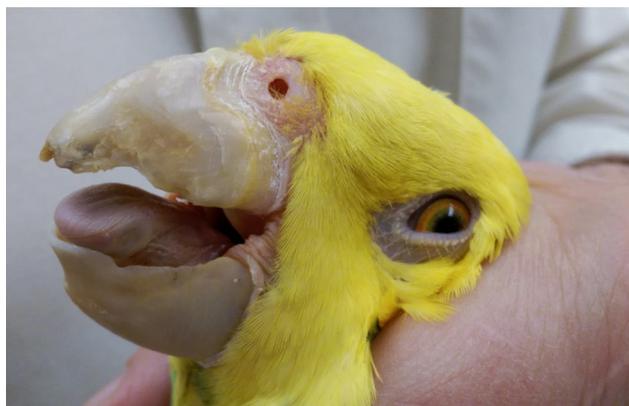
**Figure 5:** The bird from Figure 1 was examined six months after the initial injury and three days after the prosthesis fell off naturally at home. Slight thickening of the rhinotheca and mild discoloration where the prosthesis was previously attached was observed, but otherwise there were signs of normal regrowth, shape, and strength of the rhinotheca. The patient had returned to full function of the beak and was doing well.
